“NETWORK OF DANUBE WATERWAY ADMINISTRATIONS”
South-East European Transnational Cooperation Programme

STATUS QUO REPORT OF WATERWAY MAINTENANCE

RO – AFDJ

Document ID:	O 4.5	
Activity:	4.1	
Author / Project Partner:	Date:	Version:
Claudiu Dutu / AFDJ	2009_09_01	0.1
Claudiu Dutu / AFDJ	2009_11_02	0.2
Claudiu Dutu / AFDJ	2009_12_02	0.3
Claudiu Dutu / AFDJ	2010_01_31	1.0 - FINAL

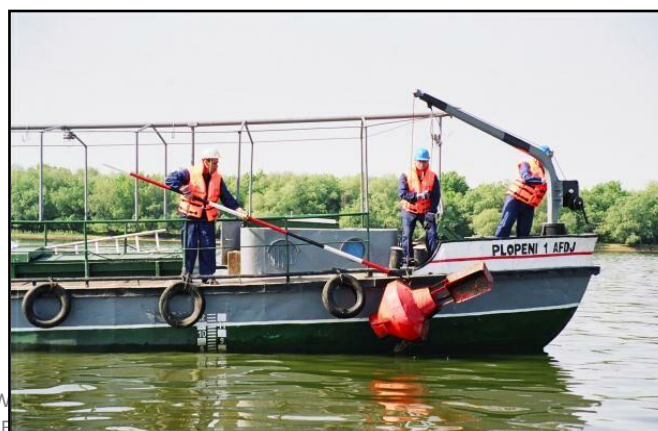
Floating signs for winter is replaced with special signals for the winter (more resistant to winter conditions). Maintenance is signalling coastal whenever needed and consists of cleaning, painting, straightening, clearing the area, etc.. Signalling coast is composed of indicators kilometres or nautical miles and coastal signals about Rules of Navigation. Signalling floating buoys consists of large (which may be electric or not) and low during winter signals from metal.

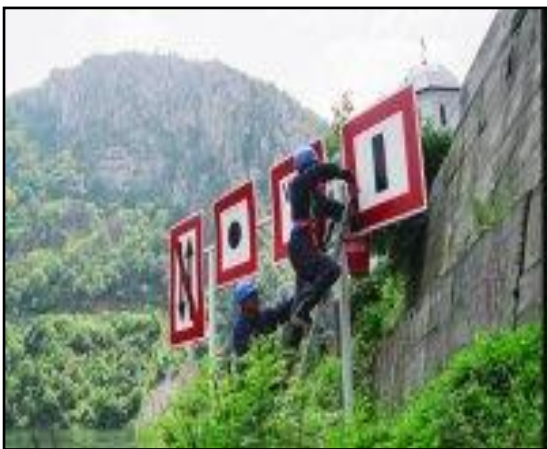
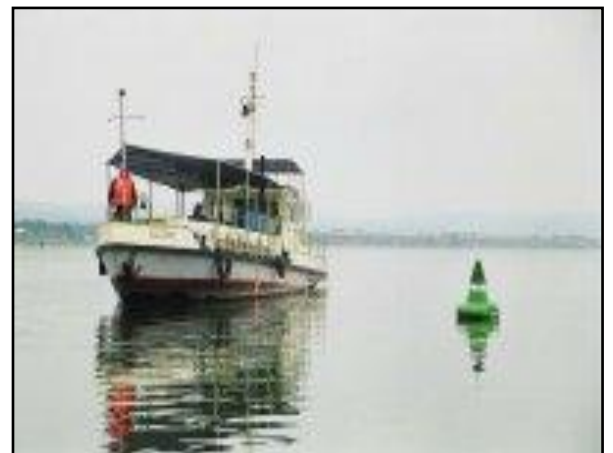
The types of signals used as DFND (Danube Commission) are:

coastal (with or without light), indicator panels, lights (with white light, yellow, red or green)

Floating: sea buoys (with or without light), river buoys (with or without light), kilometres mark (without light), nautical miles (without light).
